Mimico Creek Watershed Report Card 2013

Toronto and Region Conservation (TRCA) has prepared this Watershed Report Card on the state of forests, surface water, groundwater and stormwater conditions.

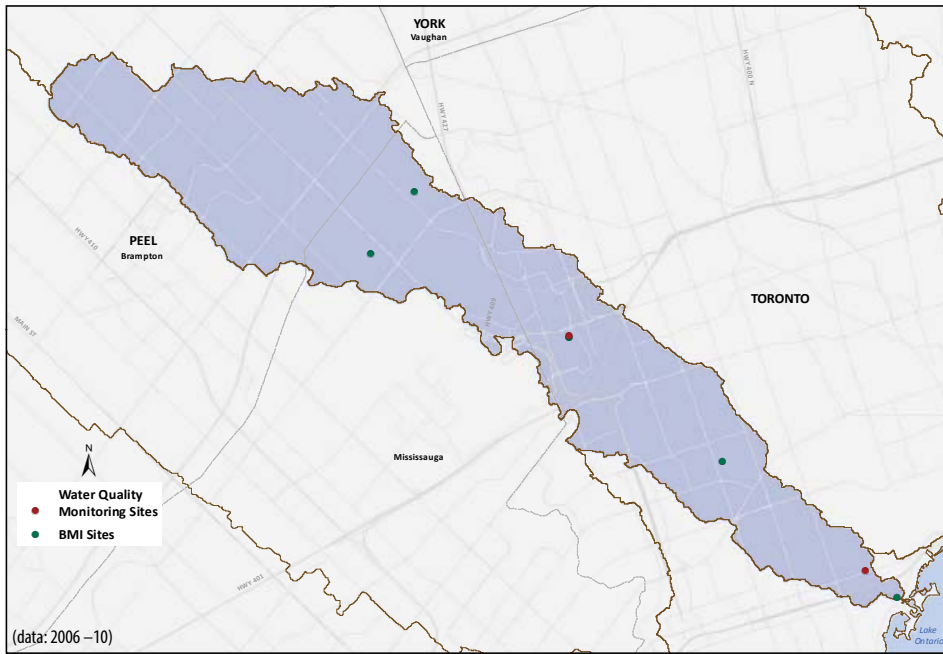
The Mimico receives an overall water quality grade of “F,” based on results from seven monitoring sites. The “Very Poor” conditions are because 96% of the watershed is urbanized.

The absence of stormwater management practices in older urban areas, the impermeable pavement covering much of the watershed and the lack of vegetation along channelized streambanks all contribute to water quality problems. These conditions limit the amount of water that can be retained and absorbed during storms, resulting in heavy run-off and frequent flash flooding. It also carries sediments, animal waste and contaminants into the watercourse. BMI and E. coli conditions are “Very Poor” in the watershed, while phosphorous is “Poor.” Significant action is needed to improve stormwater management and reduce the contaminants carried into the watercourse by run-off from local industrial, commercial and residential areas.

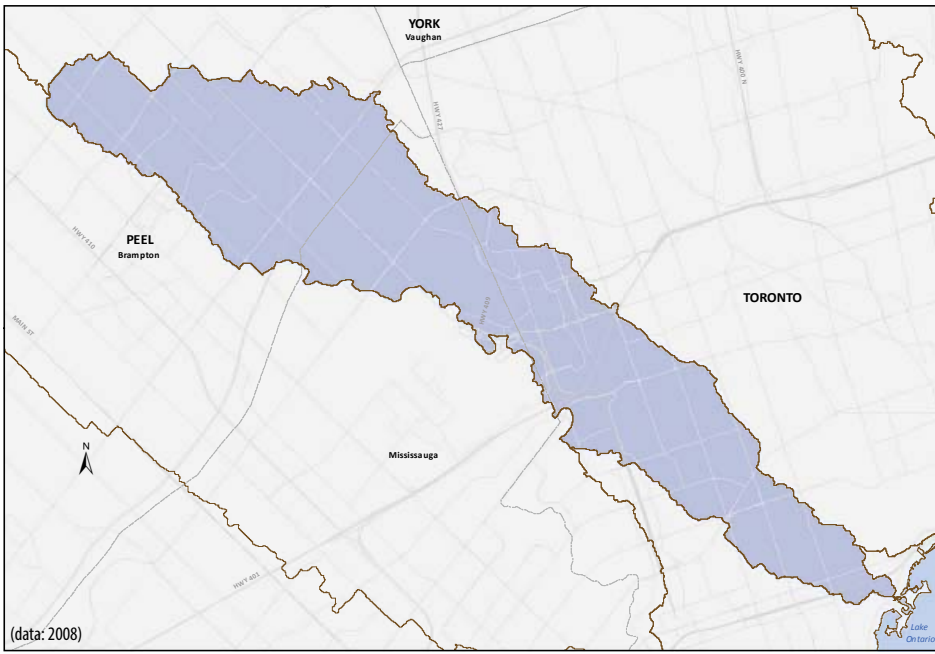
Forest conditions in the Mimico Creek watershed are considered to be “Very Poor,” earning an overall grade of “F.” Much of the original forest cover was lost due to farming, with most of the remainder to expanding urban development. Today, less than 2% of the watershed is forested and there are no large areas of interior forest left.

The vast majority of the remaining natural cover is found within river valleys or stream corridors. Due to the limited forest cover, the wildlife community is dominated by “habitat generalist species,” such as the Baltimore oriole and the chipping sparrow, which are able to adapt to urban conditions. Significant action is needed to protect the existing forest cover, restore and expand forest areas, and achieve the targets set out in TRCA's Terrestrial Natural Heritage Systems Strategy.

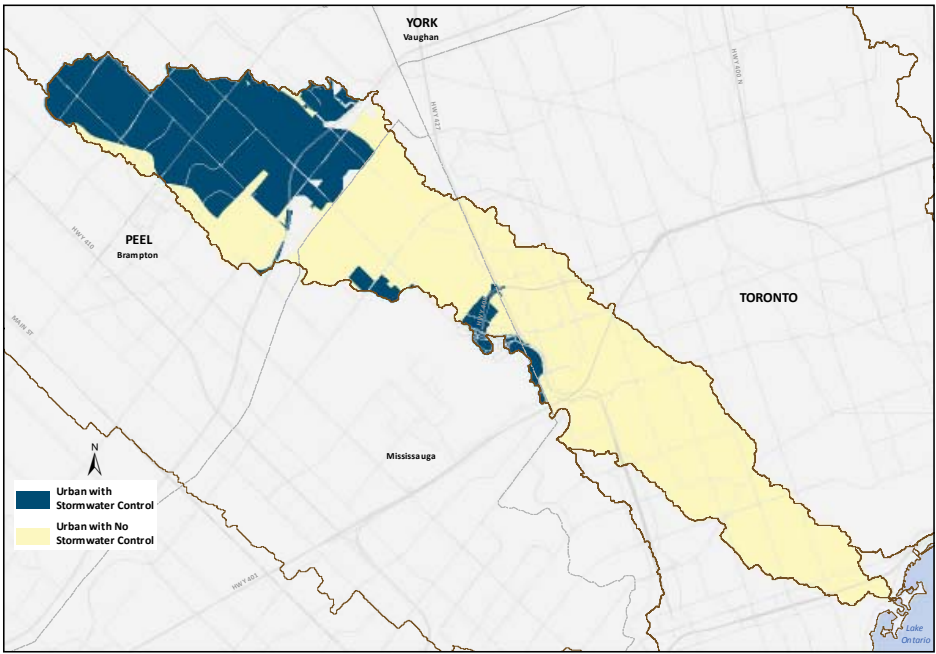
The Mimico Creek watershed receives an overall grade of “F” or “Very Poor” for stormwater management. As of 2013, only 31% of the urbanized area of the watershed has stormwater management controls.

The City of Brampton has the highest level of controls within the watershed. Additional low impact development controls — such as rain gardens green roofs and permeable parking lots that allow stormwater to seep into the ground would further reduce run-off and stabilize stream flow. The continued construction of stormwater management ponds and effective end-of-pipe controls, such as wetlands and storage tanks are also vital in restoring the health of the creek.
