Mimico Creek

WATERSHED

Report Card 2018

Toronto and Region Conservation has prepared this report card as a summary of the state of our forest and water resources.

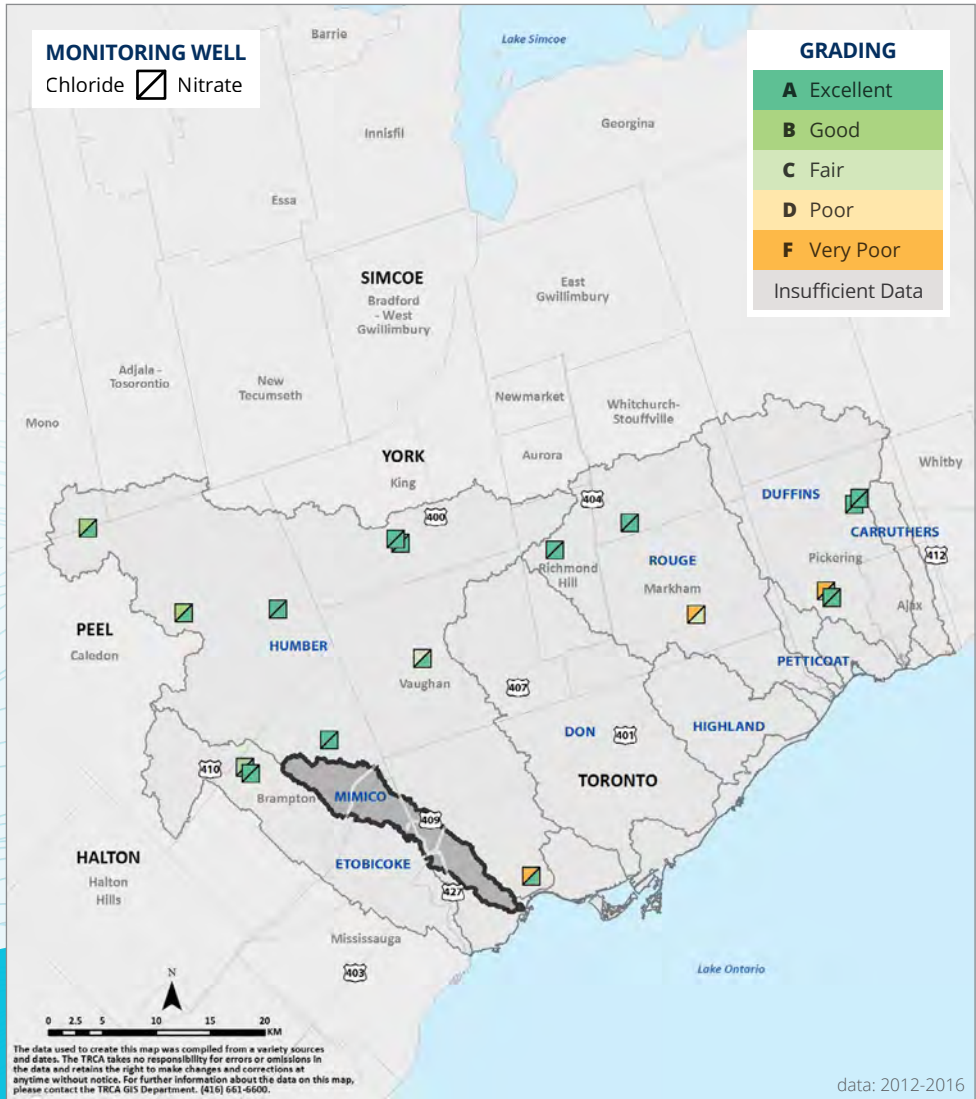
Monitoring wells are part of the Ontario Ministry of the Environment and Climate Change's Provincial Groundwater Monitoring Network (PGMN). No wells were located within Mimico Creek watershed.

- Generally, concentrations of nitrate in individual wells were better than the drinking water guidelines (‘A’ grade) across the jurisdiction.
- The 2 wells located in the nearby Etobicoke Creek watershed received ‘A’ grades for nitrate and a ‘B’ or better grade for chloride.

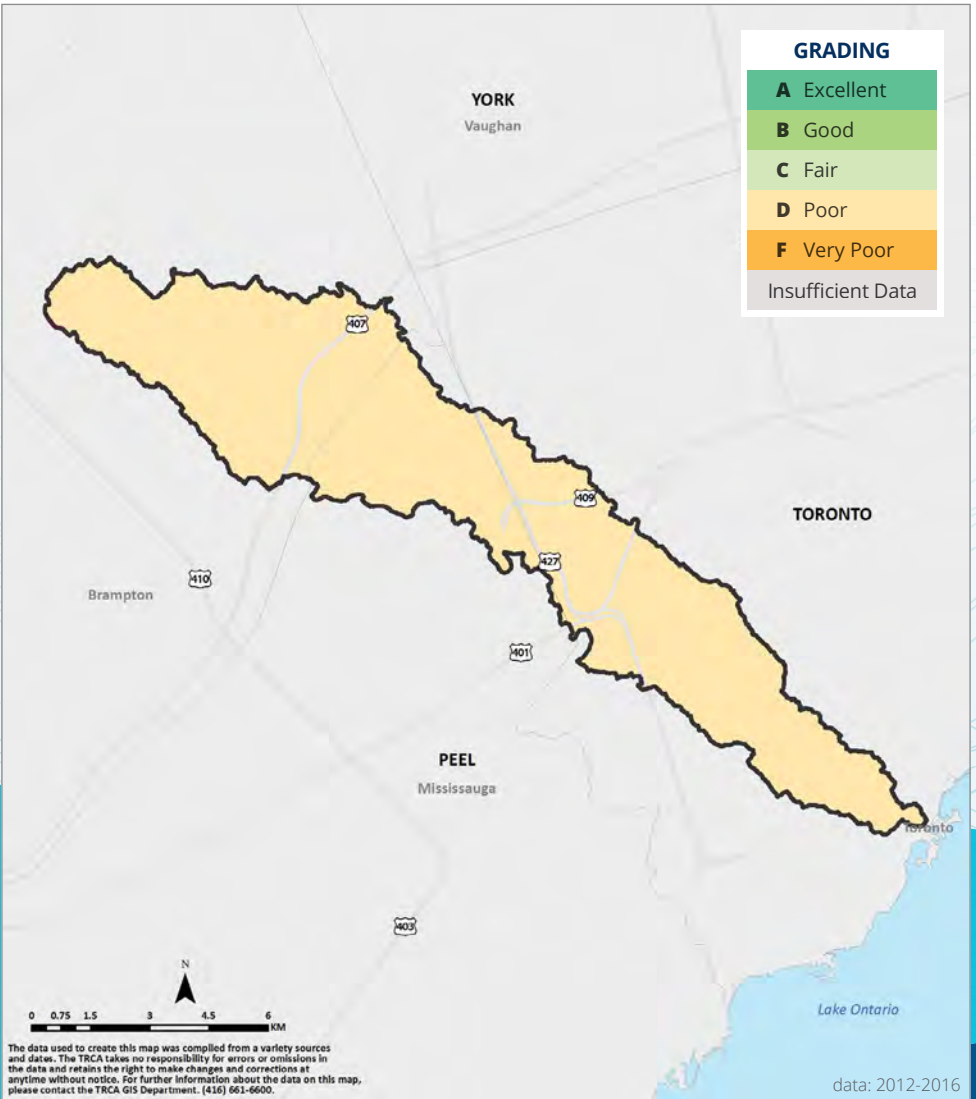
Data are based on surface water quality monitoring stations that are part of the Ontario Ministry of the Environment and Climate Change's Provincial Water Quality Monitoring Network (PWQMN) and/or TRCA's Regional Watershed Monitoring Program (RWMP).

- The Mimico Creek watershed received an overall ‘D’ grade for surface water quality which improved from an ‘F’ in 2013 report card.
- Chloride concentrations are not included in the grade, but chloride is an issue in the watershed. Almost every sample collected (98%) had a chloride concentration greater than the recommended guideline. The chloride found in streams is typically from road salt and elevated chloride concentrations can harm aquatic life.

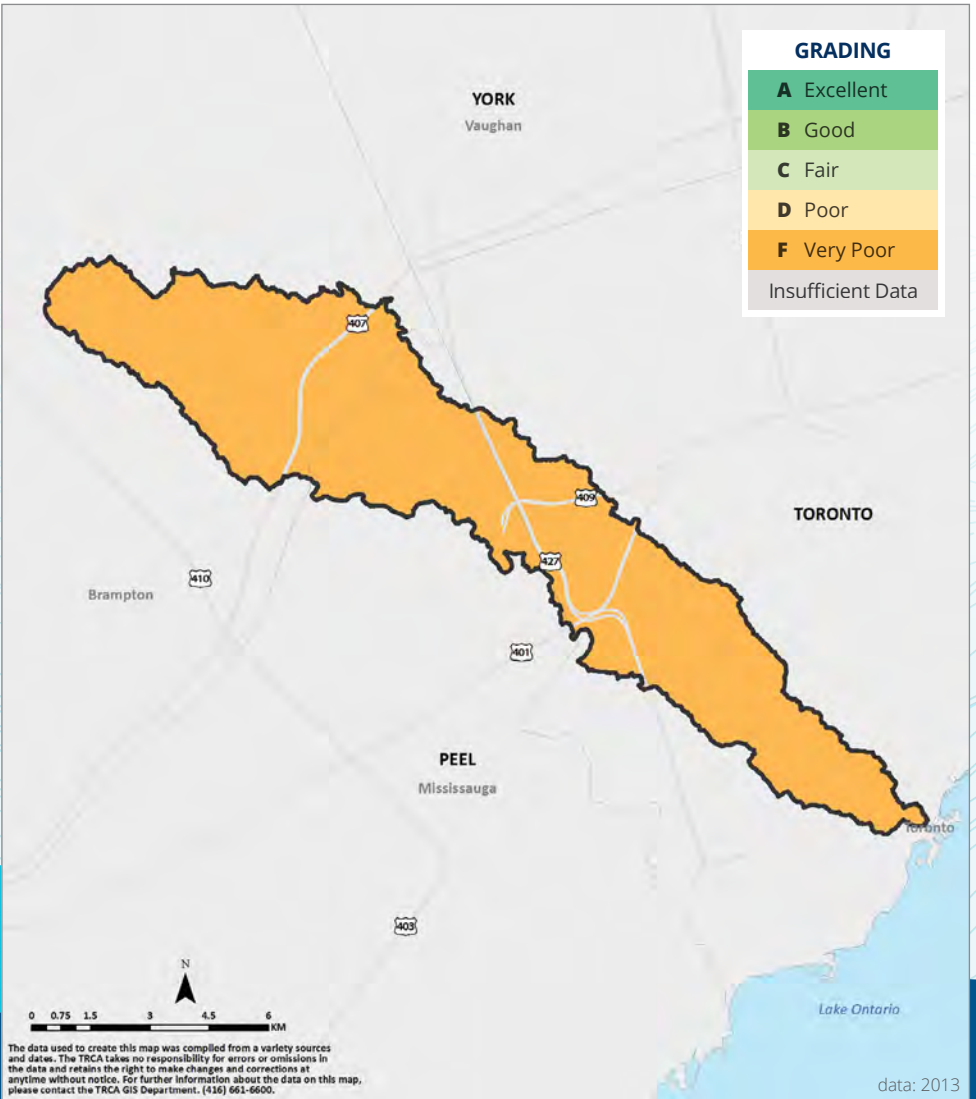
Forest condition targets were set by Conservation Ontario. TRCA has a unique set of targets for natural cover which consists of areas of natural vegetation such as forest, wetland, and meadow. TRCA specific targets are not included in this report card.

- The Mimico Creek watershed received a ‘F’ grade for forest conditions which is the same as the previous report card in 2013.
- There was about 2% forest cover, <1% interior forest cover, and 19% streamside cover. Streamside cover has increased by almost 5% since the last report card which is a sign of improvement.

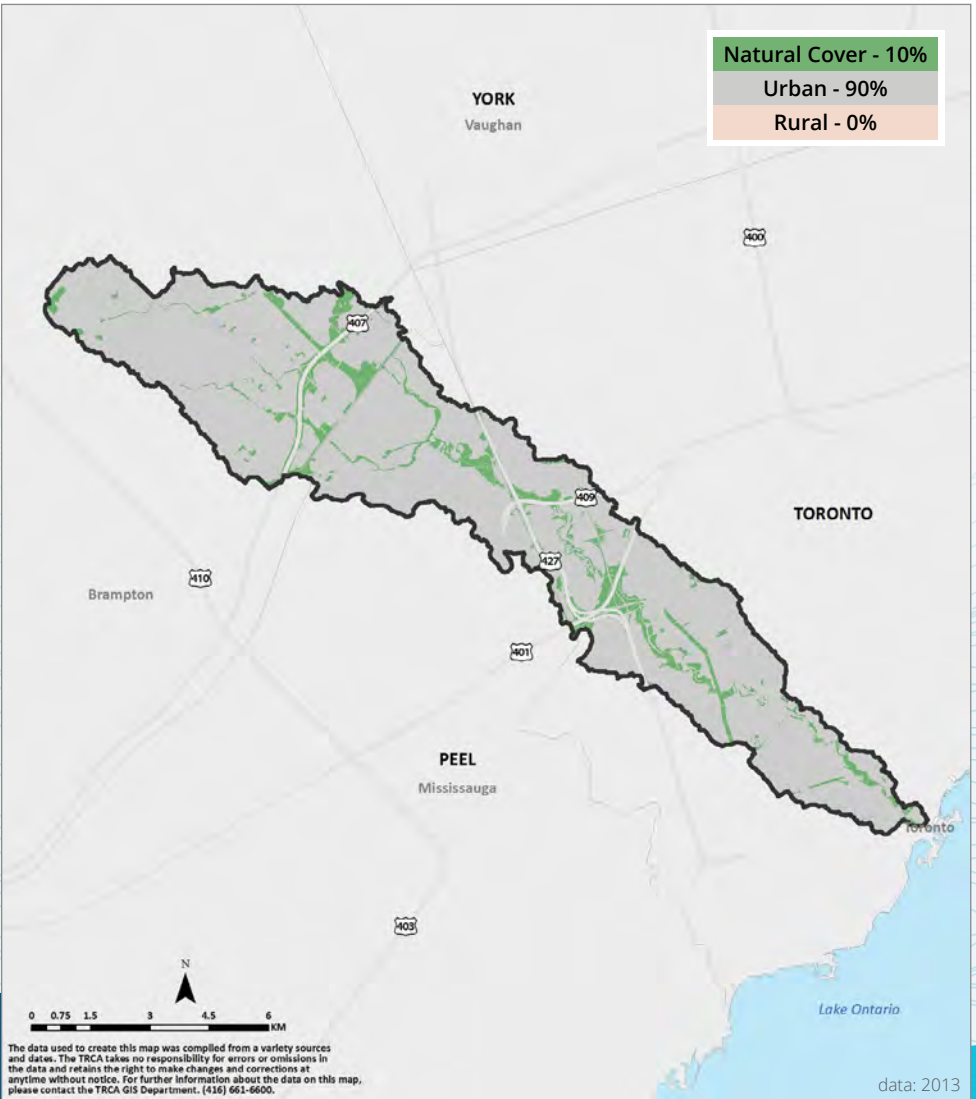
Natural cover consists of vegetation such as forest, wetland, and meadow. Distance to natural cover and size values are based on indicators recommended in scientific literature (e.g. Van den Bosch et al., 2015).

- Mimico Creek watershed has the highest proportion of urban area (90%) and the lowest proportion of natural cover (10%) in the TRCA jurisdiction.
- About half of the population in the watershed (56%) is within 300 m of natural cover greater than 1 ha in size.
- Natural cover is unevenly distributed across the Toronto region. More natural cover would mean additional opportunities to support wildlife populations and habitat, and equal access to nature for residents.
