# Carruthers Creek WATERSHED Report Card 2018

Toronto and Region Conservation has prepared this report card as a summary of the state of our forest and water resources.

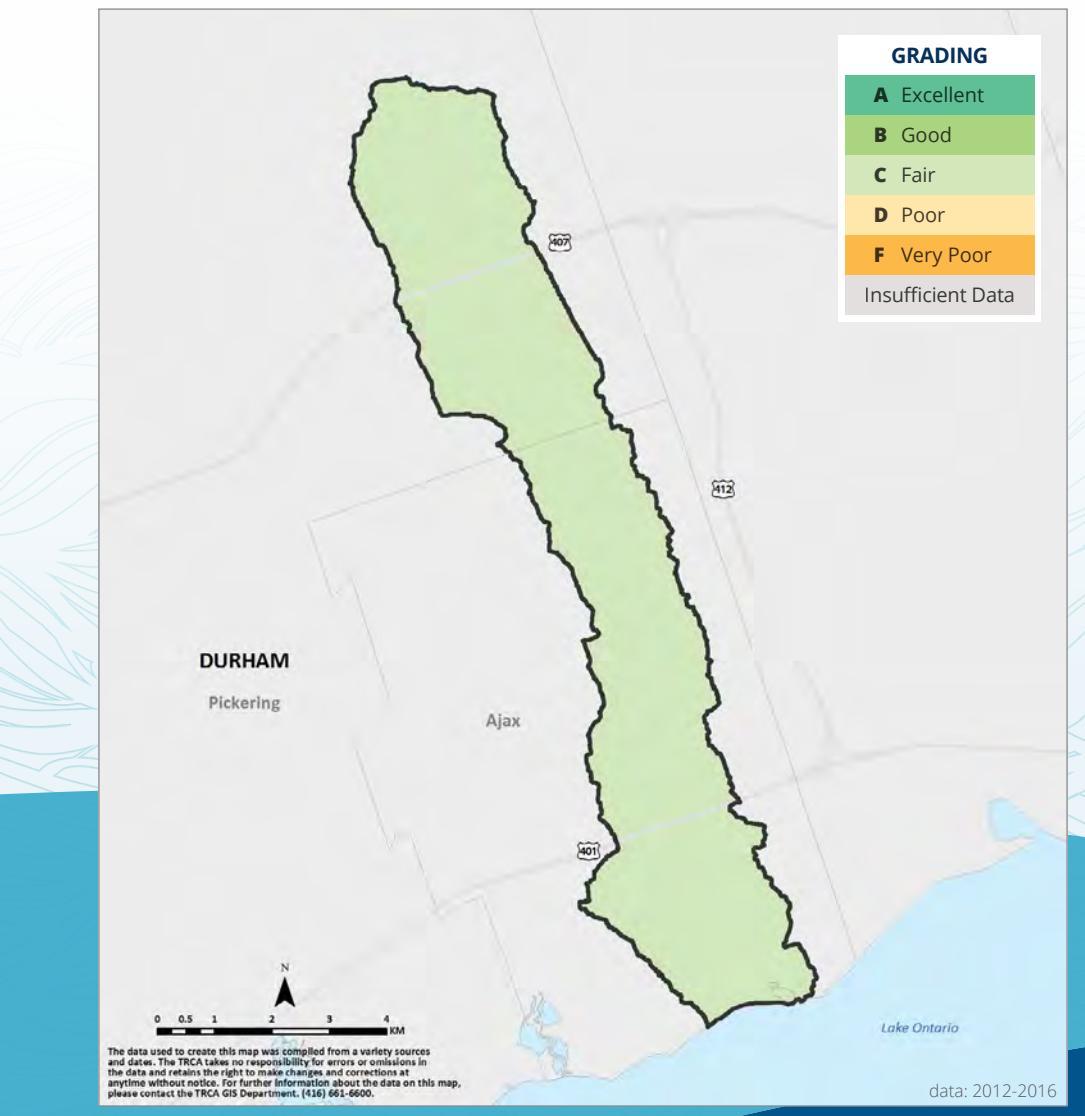
Concentrations of phosphorus and Escherichia coli (E. coli) bacteria were measured at 1 station in the Carruthers Creek watershed. Benthic invertebrates (small aquatic animals living in the sediment) were identified at 3 stations. The type and proportion of these animals are indicators of water quality conditions. These indicators were combined to provide a grade for the watershed.

- The Carruthers Creek watershed received and overall 'C' grade for surface water quality which is similar to most TRCA watersheds.
- Chloride concentrations are not part of the grade but chloride is an issue for the watershed. Almost 80% of the samples were above the recommended guideline. The chloride found in streams is typically from road salt and elevated concentrations can harm aquatic life.

Monitoring wells are part of the Ontario Ministry of the Environment and Climate Change's Provincial Groundwater Monitoring Network (PGMN). No wells were located within Carruthers Creek watershed. a are based on surface water quality monitoring stations that are part of the Ontario Ministry of the Environment and Climate nge's Provincial Water Quality Monitoring Network (PWQMN) and/or TRCA's Regional Watershed Monitoring Program (RWMP).

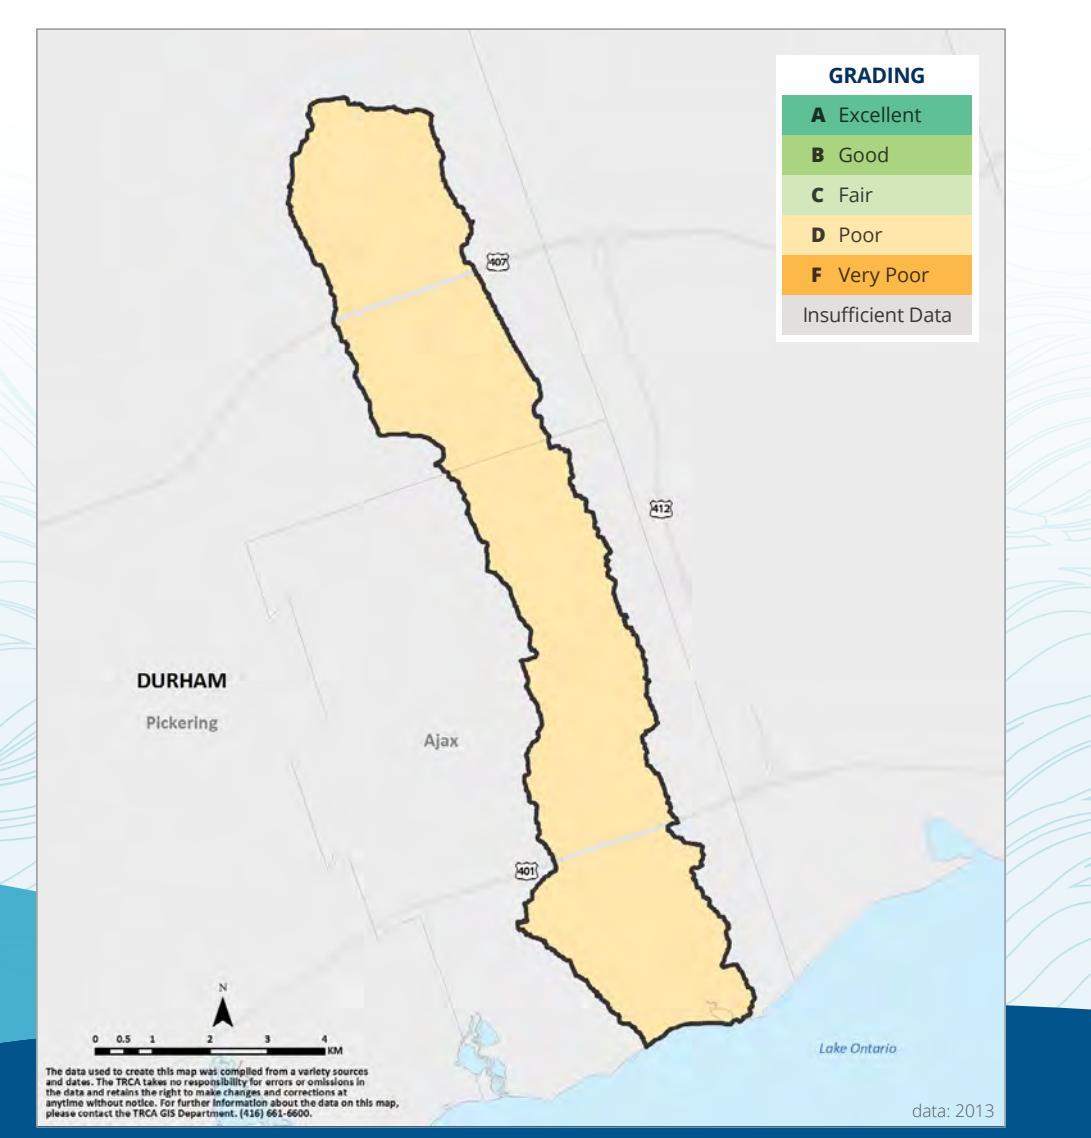
Forests help to clean our air and water, provide habitat and shade, improve water infiltration, and help to reduce both erosion and flooding. The percentages of forest cover, forest interior, and streamside cover were measured with Geographic Information Systems (GIS) and combined to provide a grade for the watershed.

- The Carruthers Creek watershed received a 'D' grade for forest conditions.
- There was about 13% forest cover, <1% interior forest cover, and 37% streamside cover.
- Forest cover and interior forest cover were similar to 2013 but streamside cover increased by about 6% which is a positive improvement for the watershed.

Forest condition targets were set by Conservation Ontario. TRCA has a unique set of targets for natural cover which consists of areas of natural vegetation such as forest, wetland, and meadow. TRCA specific targets are not included in this report card.

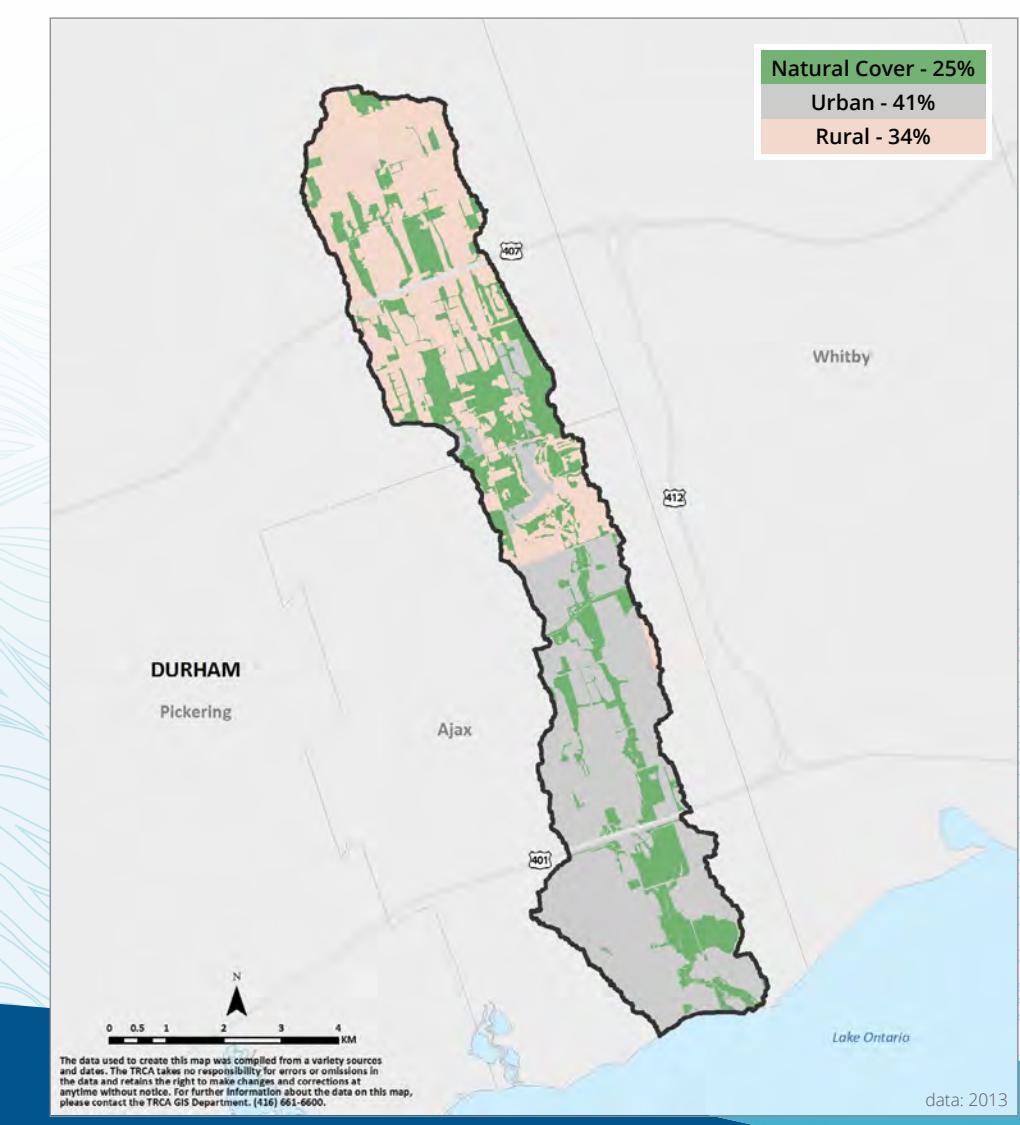
- The Carruthers Creek watershed is approximately 41% urban, 34% rural, and 25% natural cover.
- About 63% of the population in the watershed is within 300 m of natural cover greater than 1 ha in size.
- Natural cover is unevenly distributed across the Toronto region. More natural cover would mean additional opportunities to support wildlife populations and habitat, and equal access to nature for residents.

Natural cover consists of vegetation such as forest, wetland, and meadow. Distance to natural cover and size values are based on indicators recommended in scientific literature (e.g. Van den Bosch et al., 2015).
